Kiely Arborist Services LLC

March 26, 2018

Site: 7285 Bark Lane, San Jose, CA

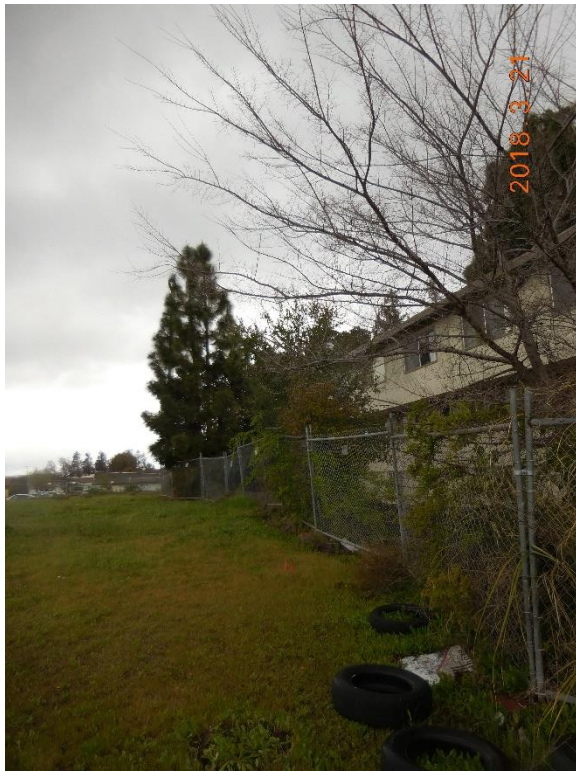
Trees #1-#3 along property line.

Tree#	Species	DBH	CON	HT/SP	Comments
1*	Chinese elm (<i>Ulmus parvifolia</i>)	10	45	20/20	Good vigor, poor form, codominant at 3 feet with a poor crotch.
2*	Coast live oak (<i>Quercus agrifolia</i>)	4-5	50	20/15	Good vigor, poor-fair form, codominant
3*	Canary Island pine (<i>Pinus canariensis</i>)	14	45	45/20	Good vigor, poor form, codominant at base with a poor crotch.
4*	Coast live oak (<i>Quercus agrifolia</i>)	12	55	25/30	Good vigor, poor form, codominant at 4 feet with a poor crotch, poor location at edge of Retaining wall.
5*	Italian cypress (<i>Cupressus sempervirens</i>)	8	55	35/15	Good vigor, fair form, poor location, near property line.
6*	Italian cypress (<i>Cupressus sempervirens</i>)	8	55	35/15	Good vigor, fair form, poor location, near property line.
7*	Italian cypress (<i>Cupressus sempervirens</i>)	8	55	35/15	Good vigor, fair form, poor location, near property line.
8*	Italian cypress (<i>Cupressus sempervirens</i>)	8	55	35/15	Good vigor, fair form, poor location, near property line.

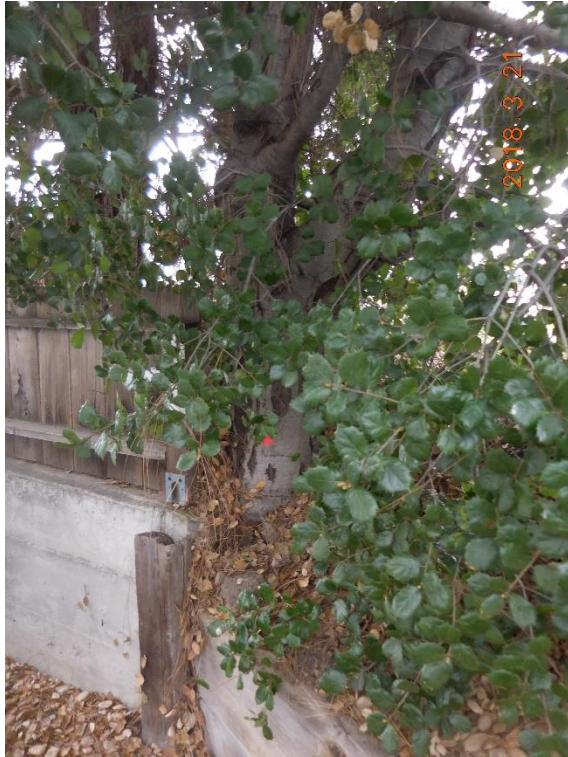
Coast live oak #4 on top of the retaining wall.

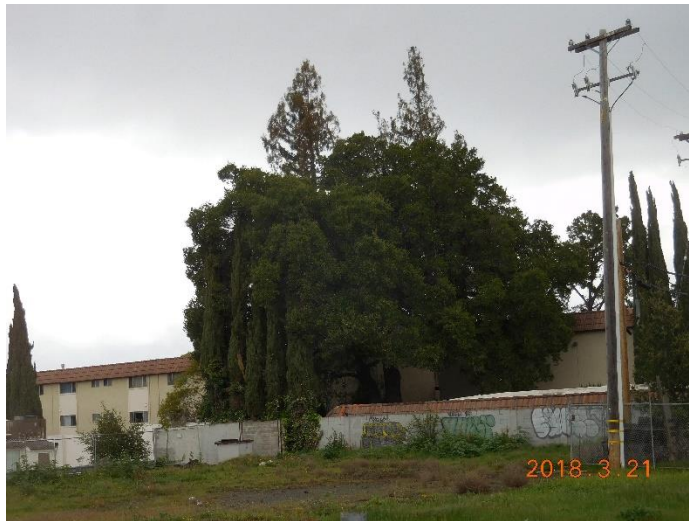
9*	Italian cypress (<i>Cupressus sempervirens</i>)	8	55	35/15	Good vigor, fair form, poor location, near property line.
10*	Coast live oak (<i>Quercus agrifolia</i>)	28-28	60	45/50	Good vigor, poor form, codominant at 3 feet, 35 feet from proposed excavation.

There are no trees on the site. All of the trees included in the report are on neighboring properties. Nine of the small trees are near the property with the large oak #10 being 35 feet from the property line. The proposed construction should have no negative effects on the large oak.

Neighbor's oak #10 and Italian cypress #5-#9 trees near property line.

Tree protection zones should be established and maintained throughout the entire length of the project. Fencing for the protection zones should be 6-foot-tall metal chain link type supported by 2-inch diameter metal poles pounded into the ground to a depth of no less than 2 feet. The support poles should be spaced no more than 10 feet apart on center. The location for the protection fencing should be placed at 10X the trees diameter where possible.
